## Minerals Inspection Report

Mine Name: Fox Canyon	Permit Number: S/49/0080	Mine Status: Active
Operator Name: Beck and Beck Construction	Inspection Date: 04/05/2016	Permit Fees: Paid
Inspector(s): A. Abate	Inspection Time: 3:00 PM	Bond Amount: \$60,500
Attendee(s):	Weather: Clear 50s	Bond Escalation: 01/01/2019
Inspection Purpose: Follow up from enforcement		Prior Inspection: 1/12/2016

### Fox Canyon Mine S/49/0080

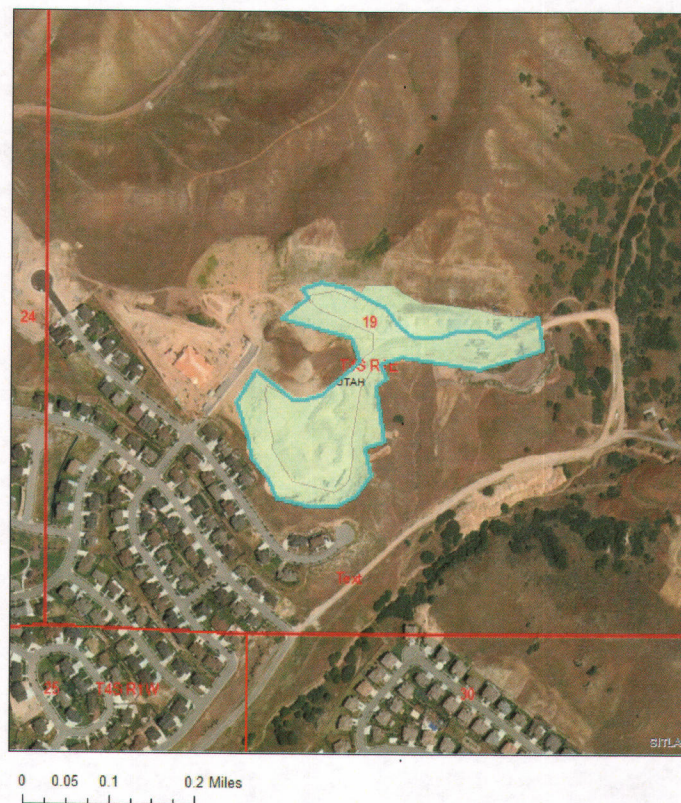
Disturbance footprint January 2016

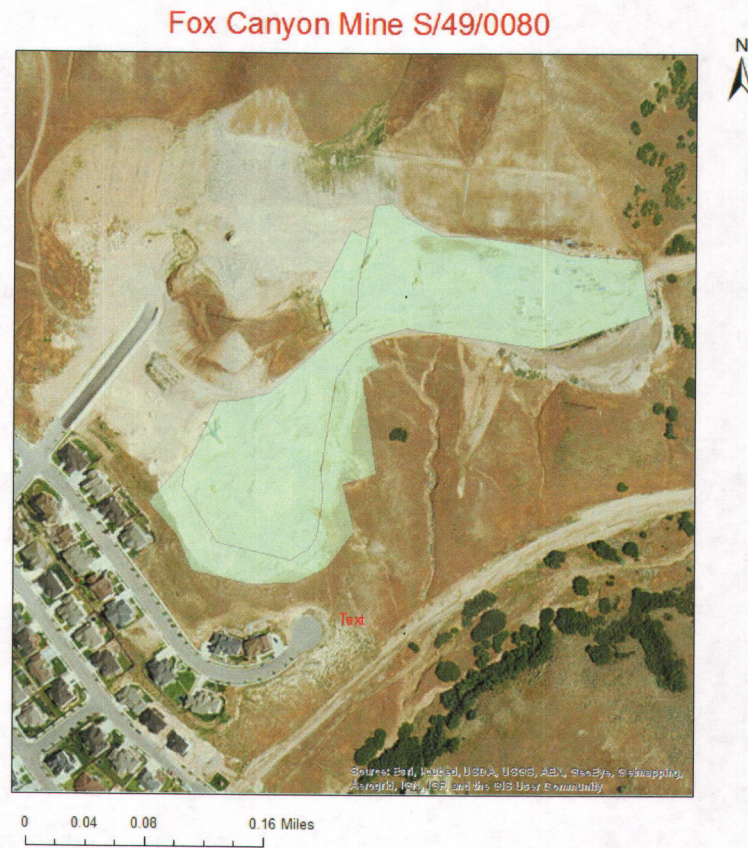
5. <i>Roads (maintenance, surfacing, dust control, safety)</i>	<input type="checkbox"/>	<input type="checkbox"/>
6. <i>Reclamation</i>	<input checked="" type="checkbox"/>	<input type="checkbox"/>
Some reclamation work appears to have been undertaken on the northern side of the permit area. The operator is in the process of grading the land to make way for a residential subdivision.

Reclamation activities to date as of April 2016

Cessation Order MC-2016-60-01 was issued on 1/14/2016 for expanding beyond the 5-acre small mine permit boundary. The abatement required the operator to reclaim at least 7 acres of the operation in order to continue to qualify for a small mine permit. The abatement also required the operator post a reclamation bond for \$60,500 for the current 12 acres of disturbance. The operator is currently in the process of reclaiming the area and has posted the required reclamation bond. MC-2016-60-01 is recommended for termination.
